TECHNICAL REPORT HL-90-18

RIO PUERTO NUEVO FLOOD-CONTROL PROJECT SAN JUAN, PUERTO RICO

Hydraulic Model Investigation

Prepared for US Army Engineer District, Jacksonville
Jacksonville, Florida 32232-0019

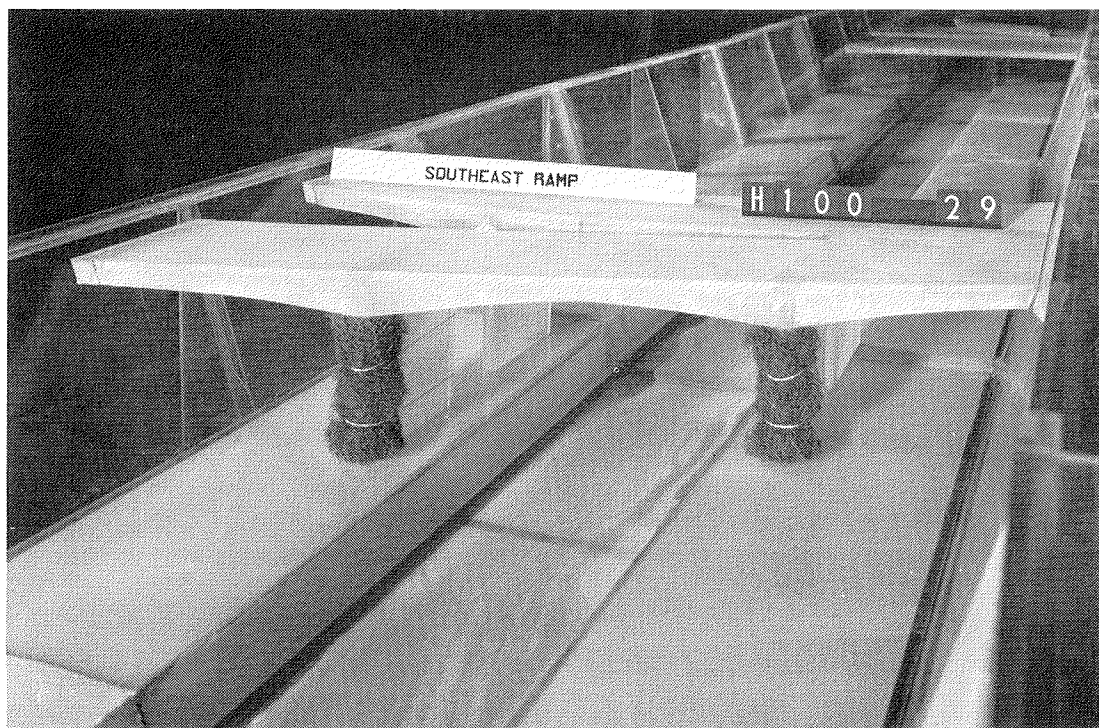
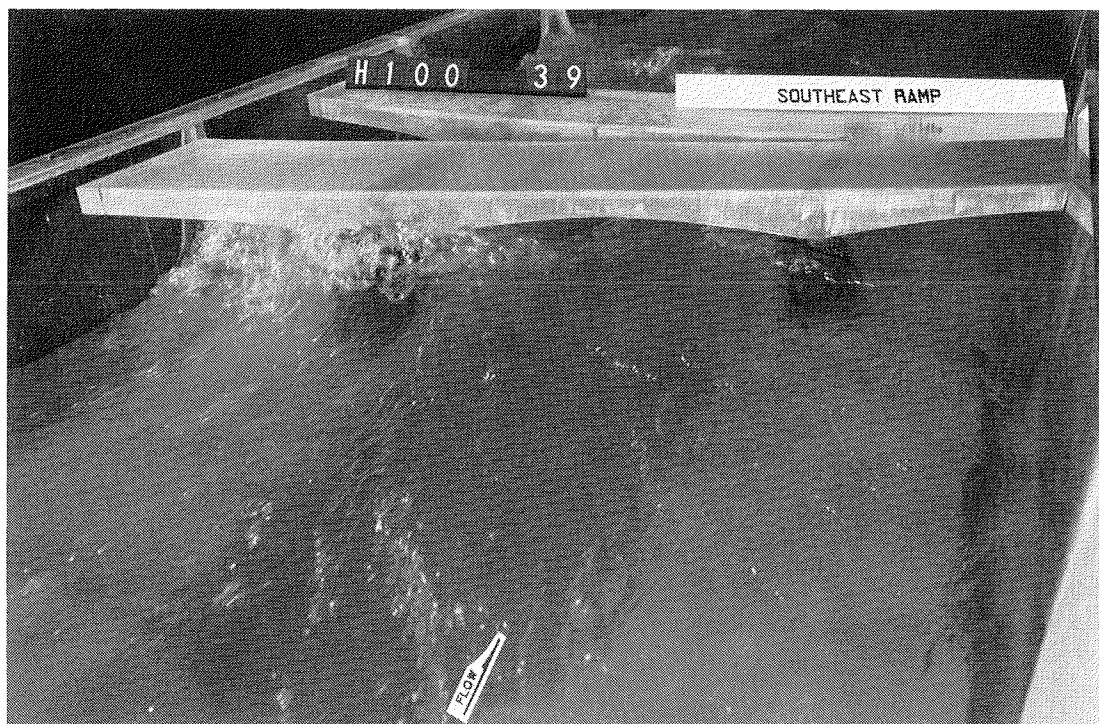
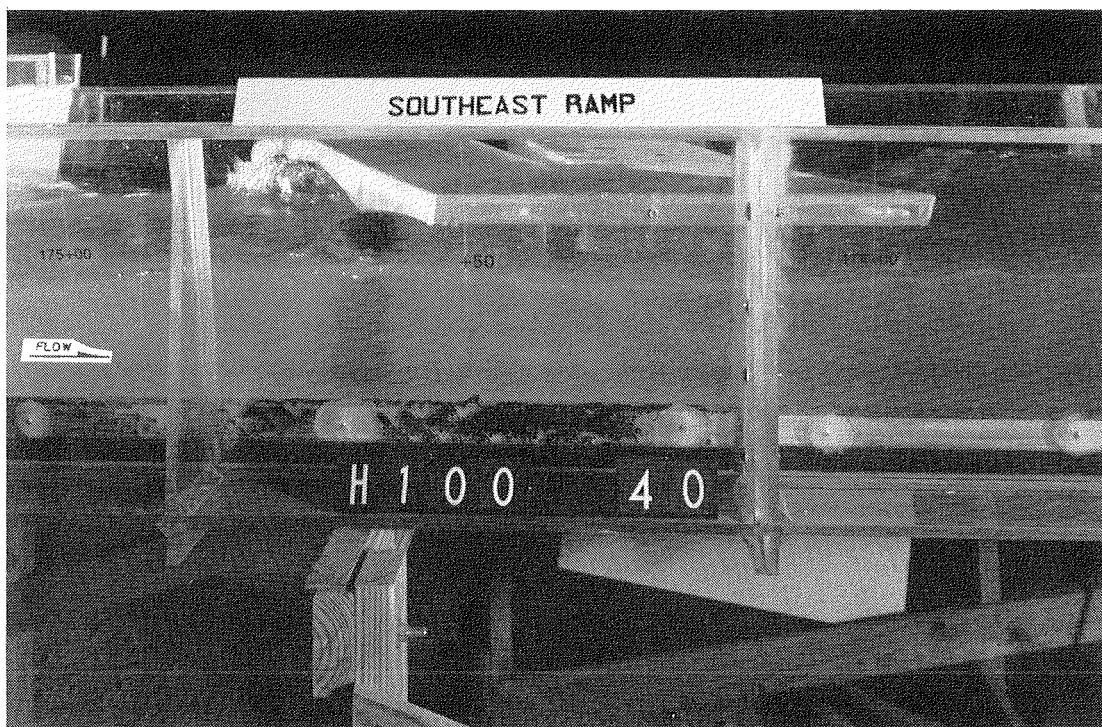
a. Dry bed looking downstream

b. Looking downstream

Photo 8. Flow conditions, Southeast Ramp Bridge with debris on piers, discharge 49,600 cfs, $n = 0.015$ (Continued)

c. Elevation view

12. Due to the high potential for debris accumulations on the bridge piers, tests were conducted to determine the effects of 2 ft of debris on each side of the bridge piers on the capacity of the bridges. Flow conditions with the debris accumulation are shown in Photos 8-11. Test results indicated that the Pinero Avenue Bridge would be overtopped with a discharge of 44,600 cfs (Photo 9), and a buildup of flow was noted upstream of the center line of the piers at the other bridges. Maximum water-surface elevations resulting from debris accumulation are provided in Table 4 and Plate 16.

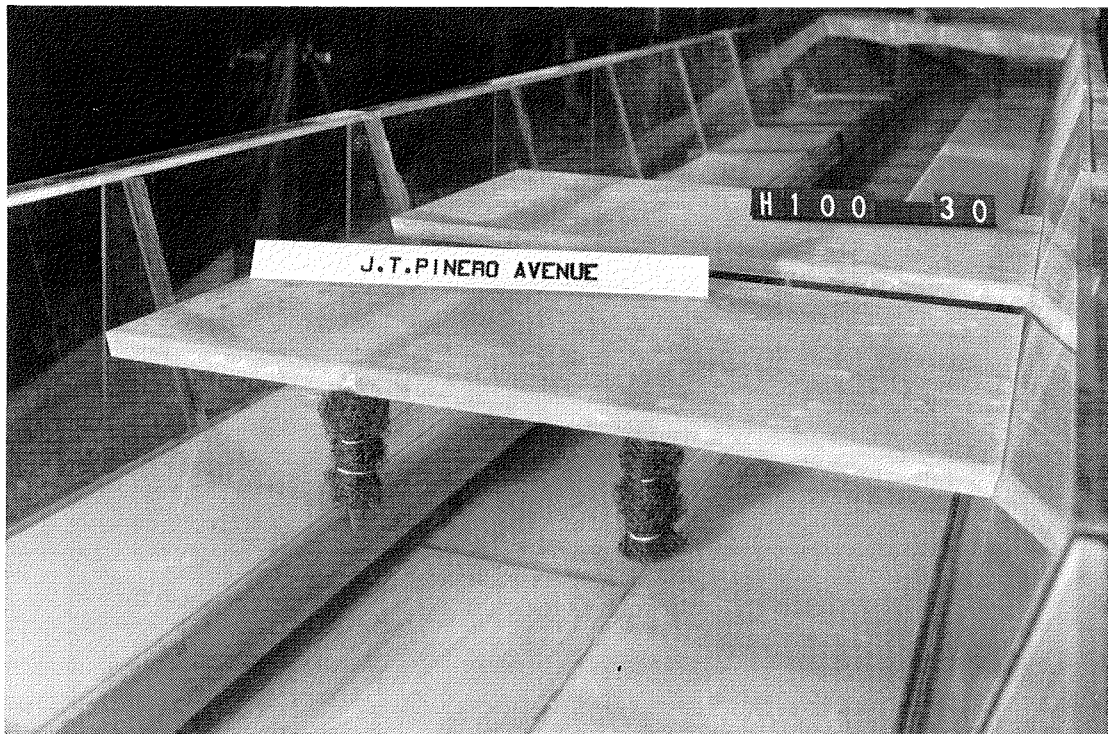
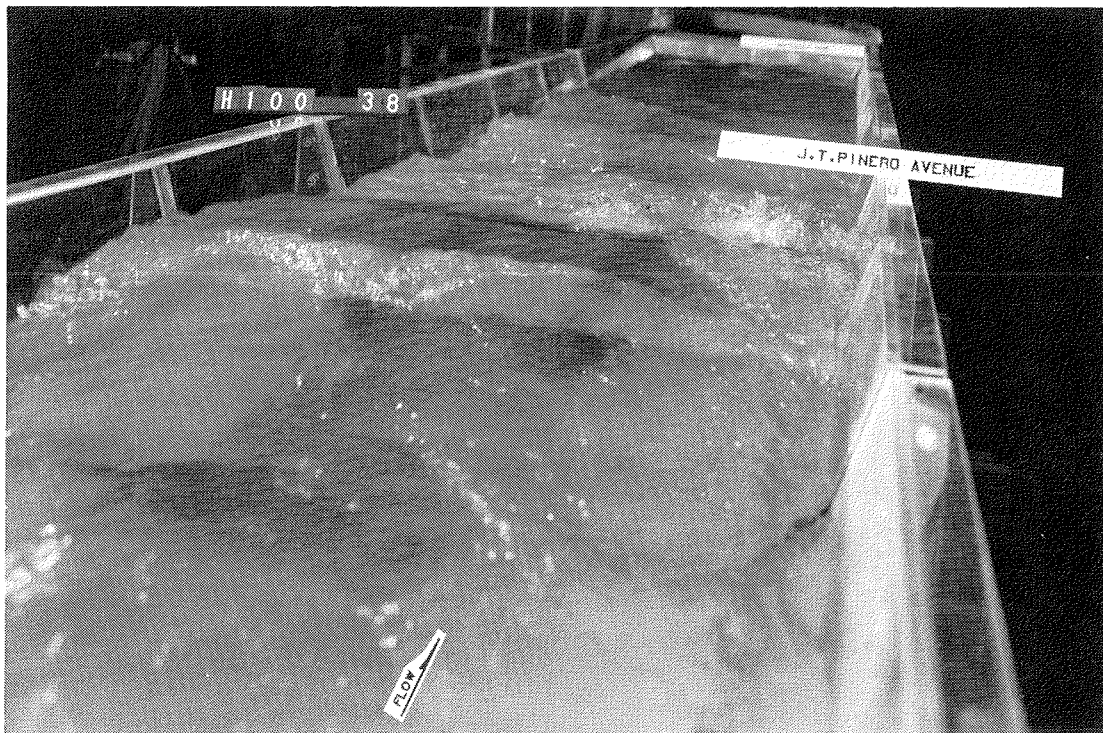
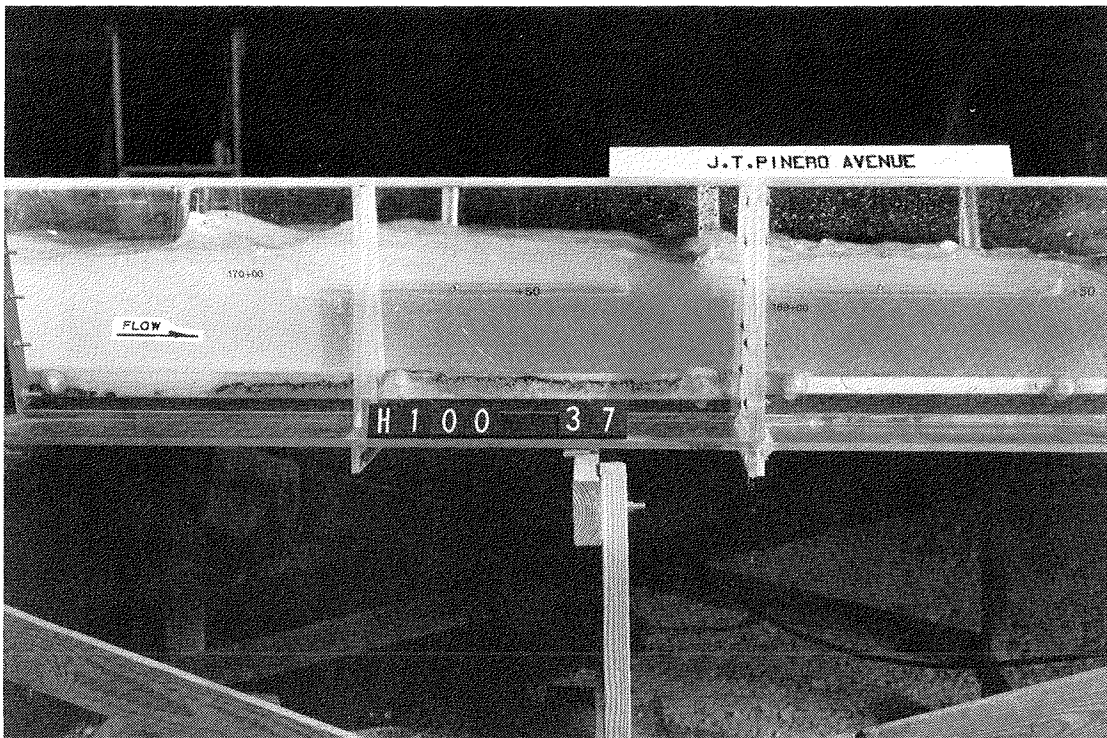
a. Dry bed looking downstream

b. Looking downstream

Photo 9. Flow conditions, Pinero Avenue Bridge with debris on piers,
discharge 44,600 cfs, $n = 0.015$ (Continued)

c. Elevation view

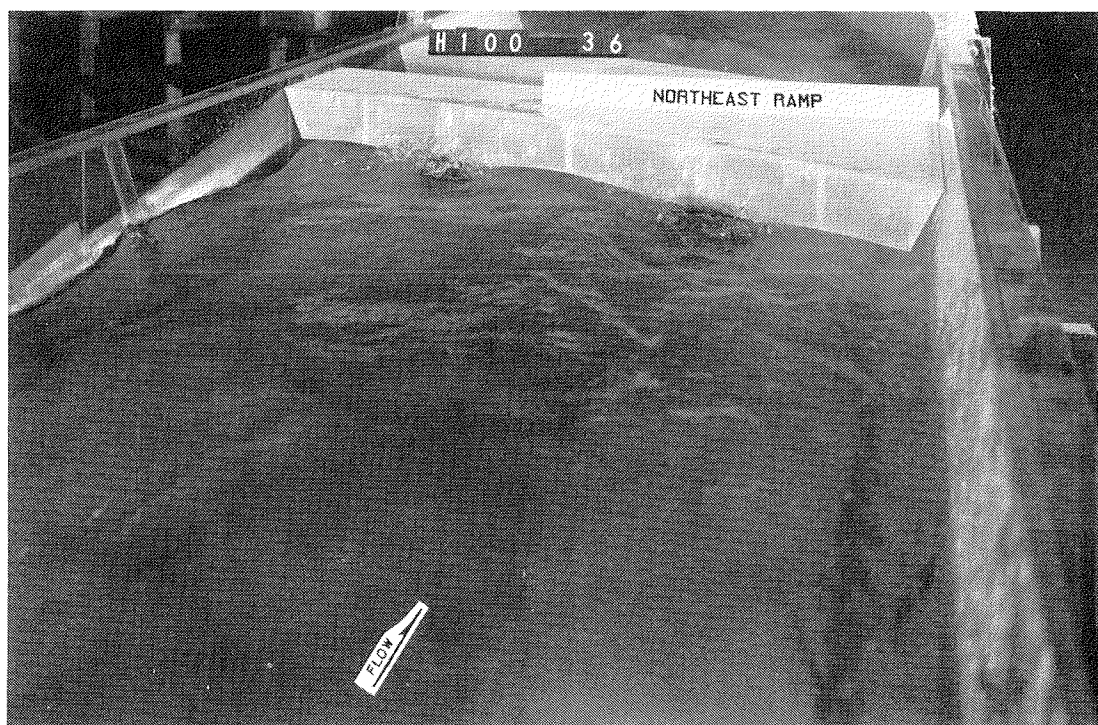
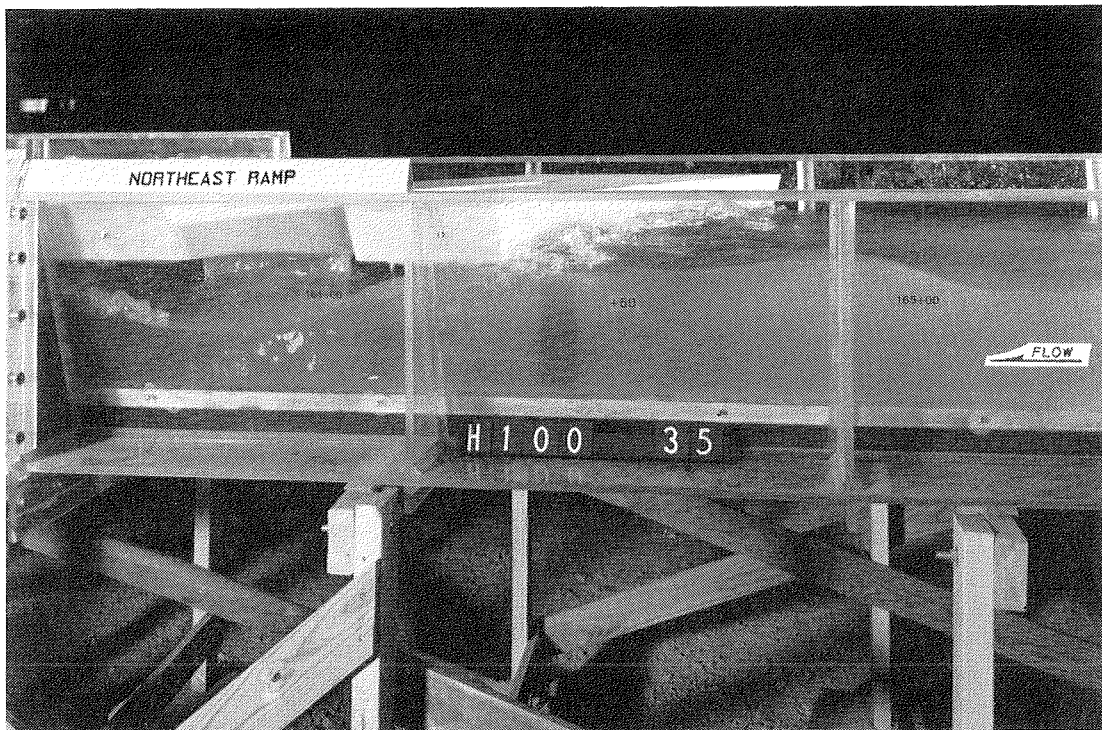
b. Looking downstream

Photo 10. Flow conditions, Northeast Ramp Bridge with debris on piers,
discharge 44,600 cfs, $n = 0.015$ (Continued)

c. Elevation view

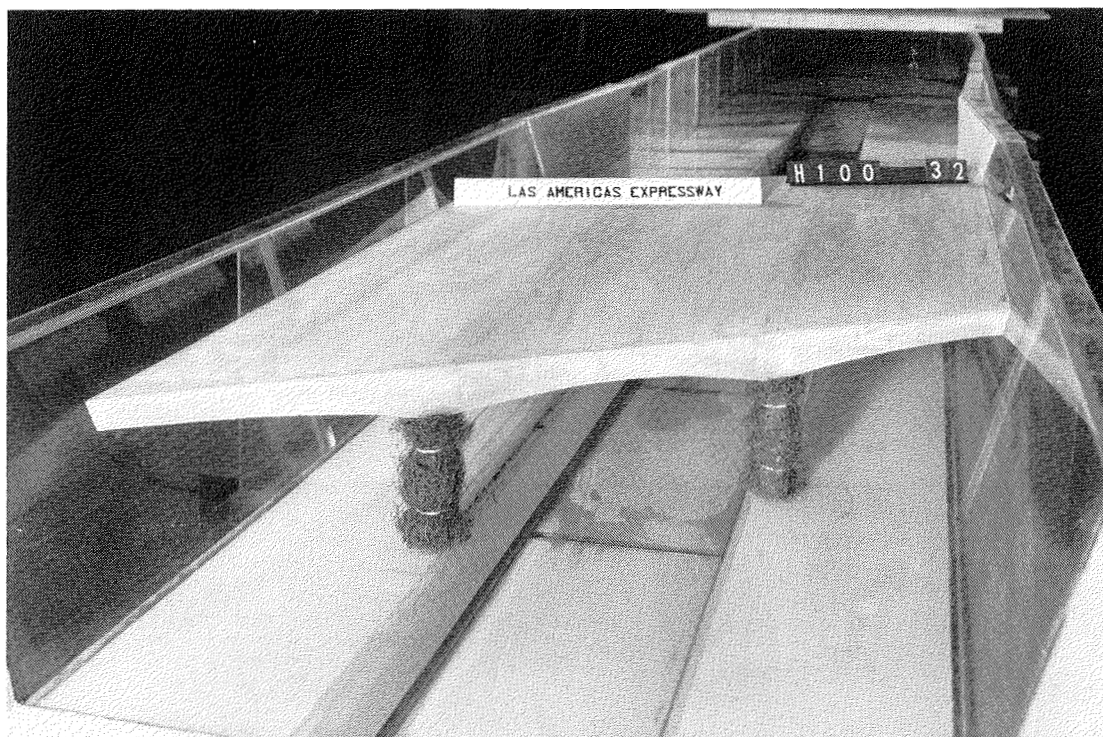
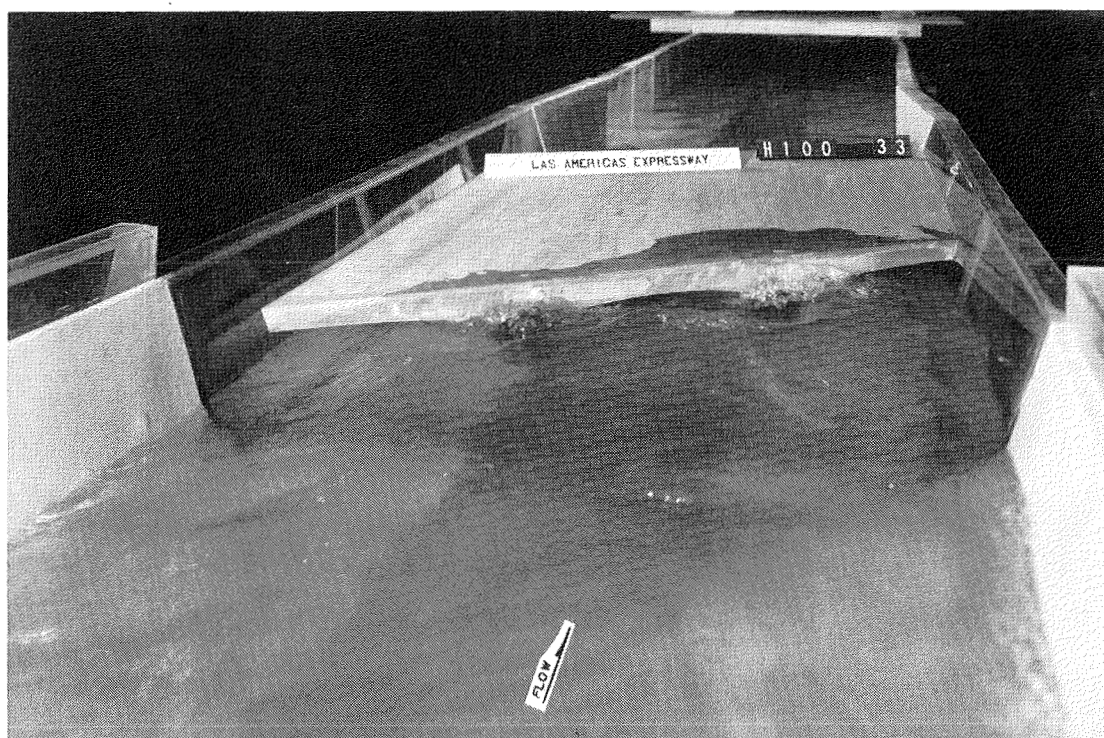
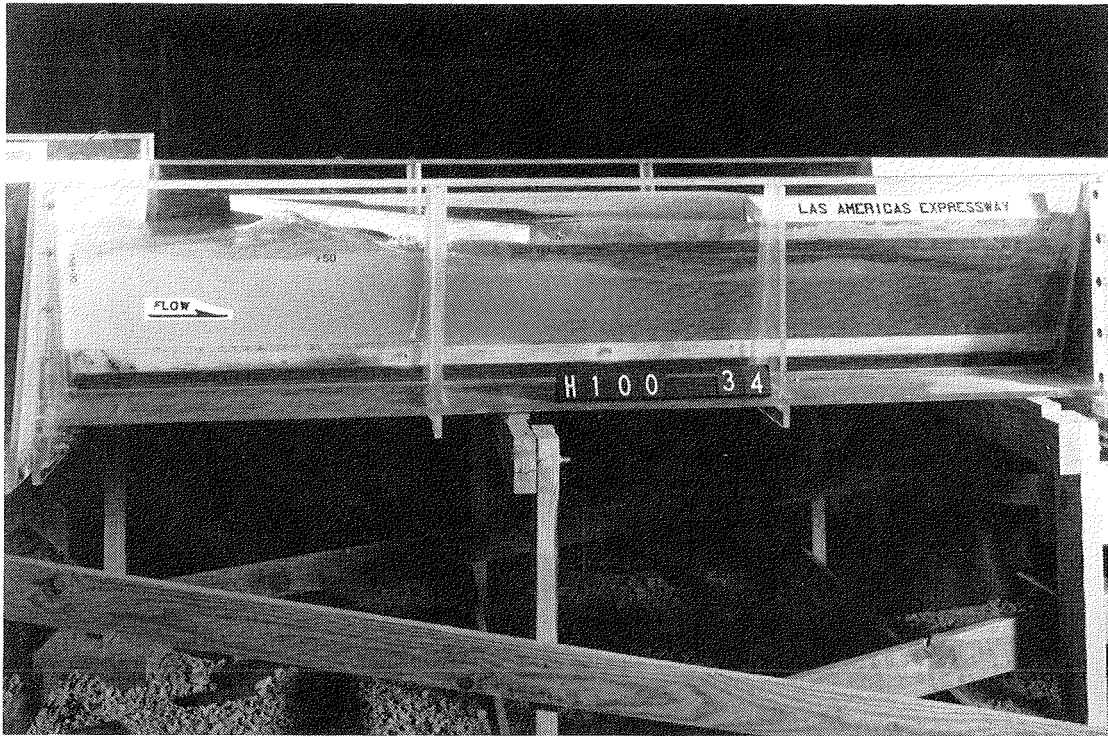
a. Dry bed looking downstream

b. Looking downstream

Photo 11. Flow conditions, Las Americas Expressway Bridge with debris on piers, discharge 44,600 cfs, $n = 0.015$ (Continued)

c. Elevation view

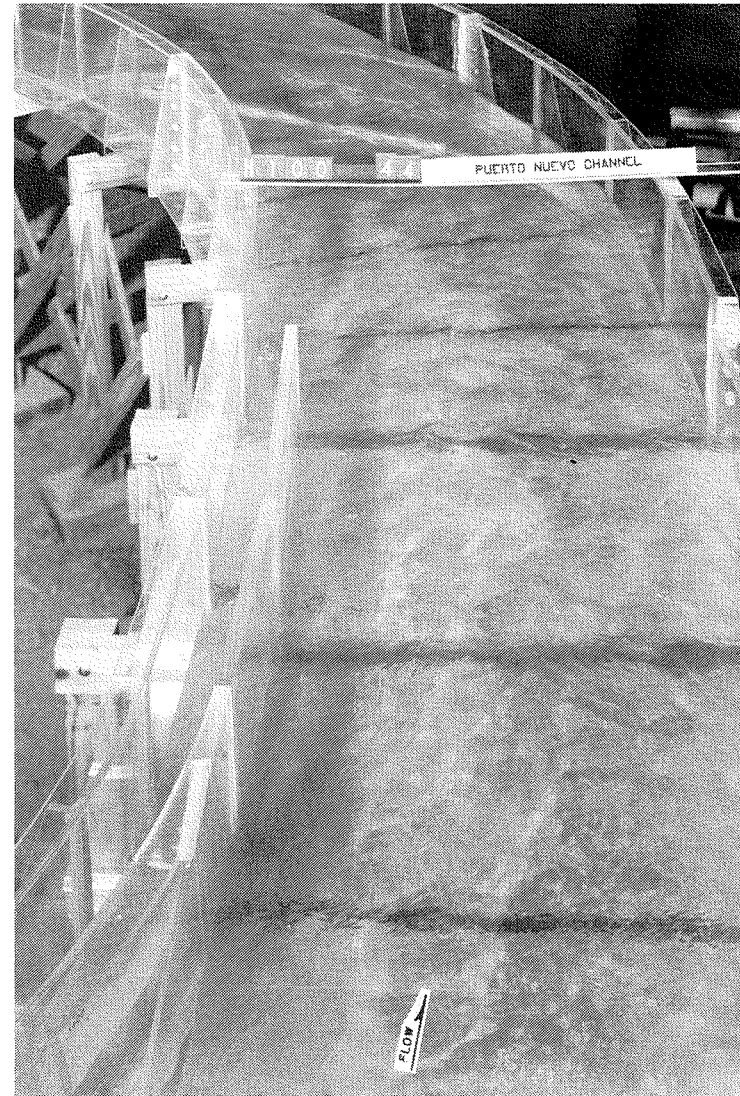
b. Discharge 37,900 cfs in Puerto Nuevo, discharge 4,200 cfs in Buena Vista Diversion

Photo 12. Flow conditions, type 2 design channel with type 4 design Puerto Nuevo/Buena Vista Diversion confluence wall, $n = 0.015$

14. In addition to the type 1 (original) design shown in Plate 17, four other confluence divider walls were tested. The details of these Puerto Nuevo/Buena Vista Diversion confluence walls are presented in Plates 18-21. The type 4 design confluence wall in conjunction with the type 2 design channel resulted in satisfactory flow conditions in the confluence vicinity

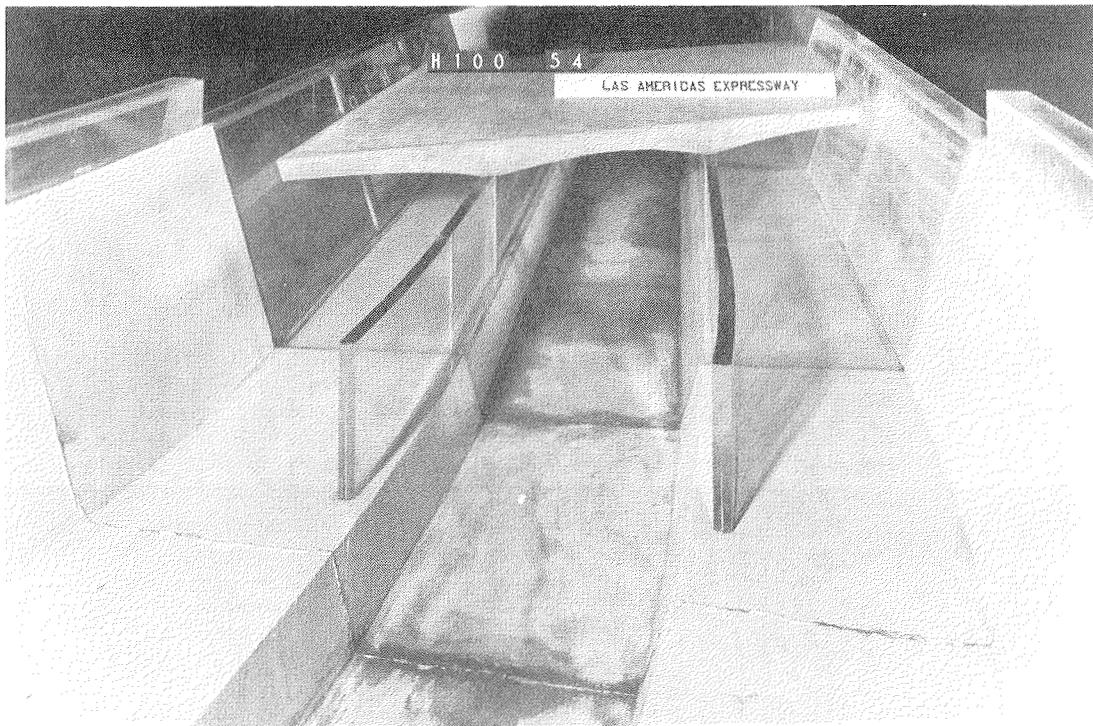
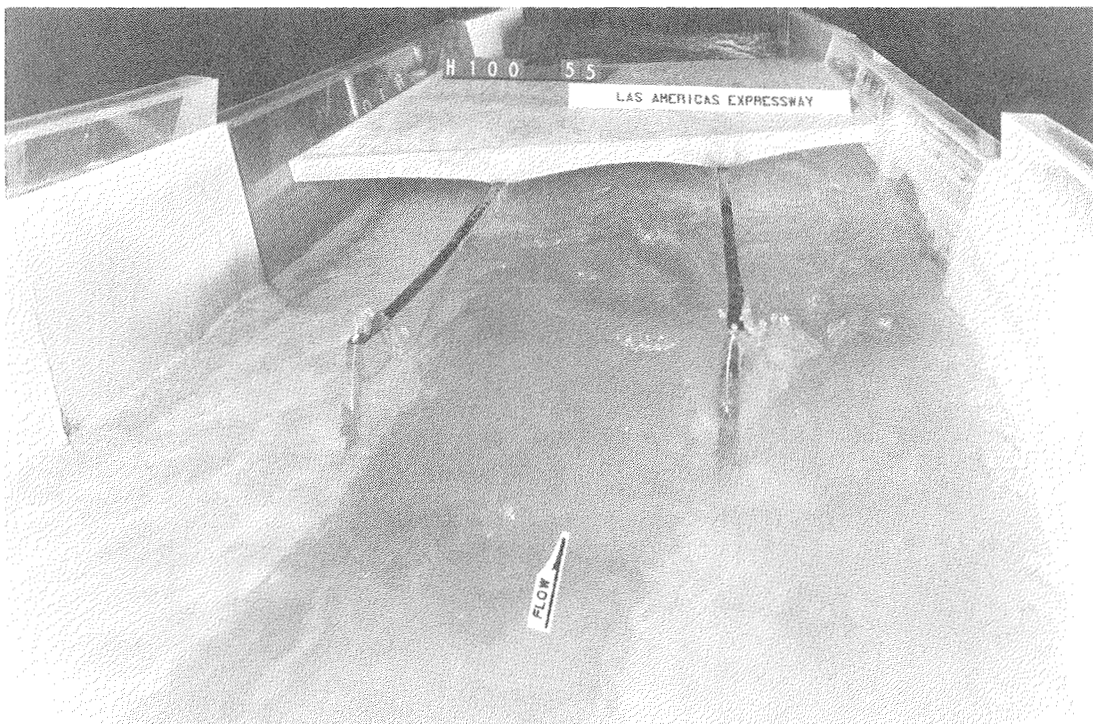
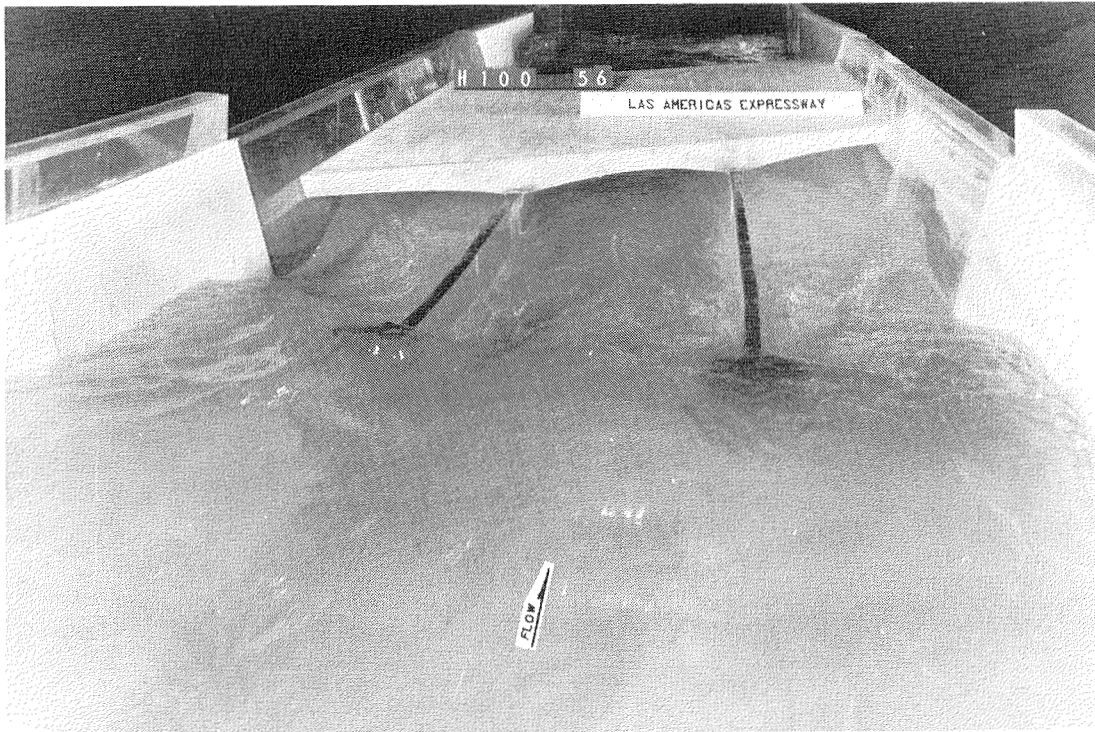
a. Dry bed looking downstream

b. Clean piers

Photo 13. Flow conditions, type 3 design Las Americas Bridge piers, discharge 44,600 cfs, $n = 0.015$ (Continued)

c. With debris on piers

17. The Las Americas Expressway Bridge piers were further modified by extending the piers an additional 50 ft upstream (type 3 design, Plate 24, Photo 13a). Acceptable flow conditions resulted from the type 3 design bridge piers for both clean piers (Photo 13b) and piers having an accumulation of debris (Photo 13c). Maximum water-surface elevations for the type 2 design Pinero Avenue Bridge piers and the type 3 design Las Americas Expressway Bridge piers are presented in Tables 6 and 7 and Plates 25 and 26. It should be noted that tests conducted with debris on bridge piers did not include debris on the type 2 design Pinero Avenue Bridge piers since it was assumed that the design would inhibit accumulation.

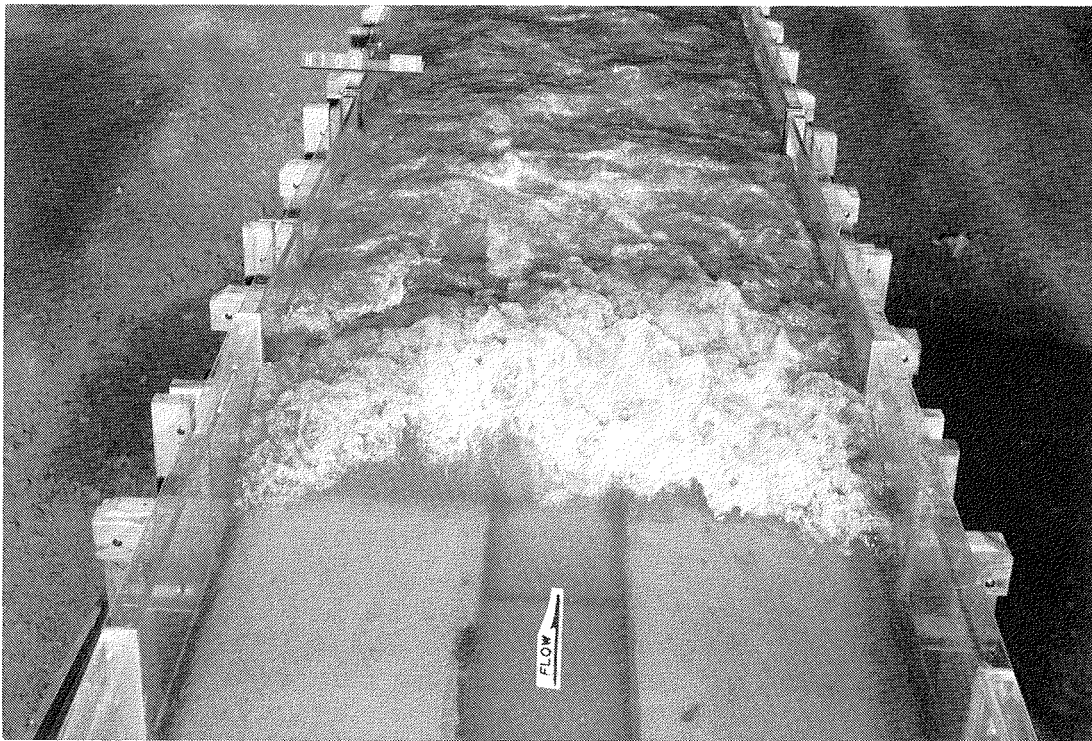
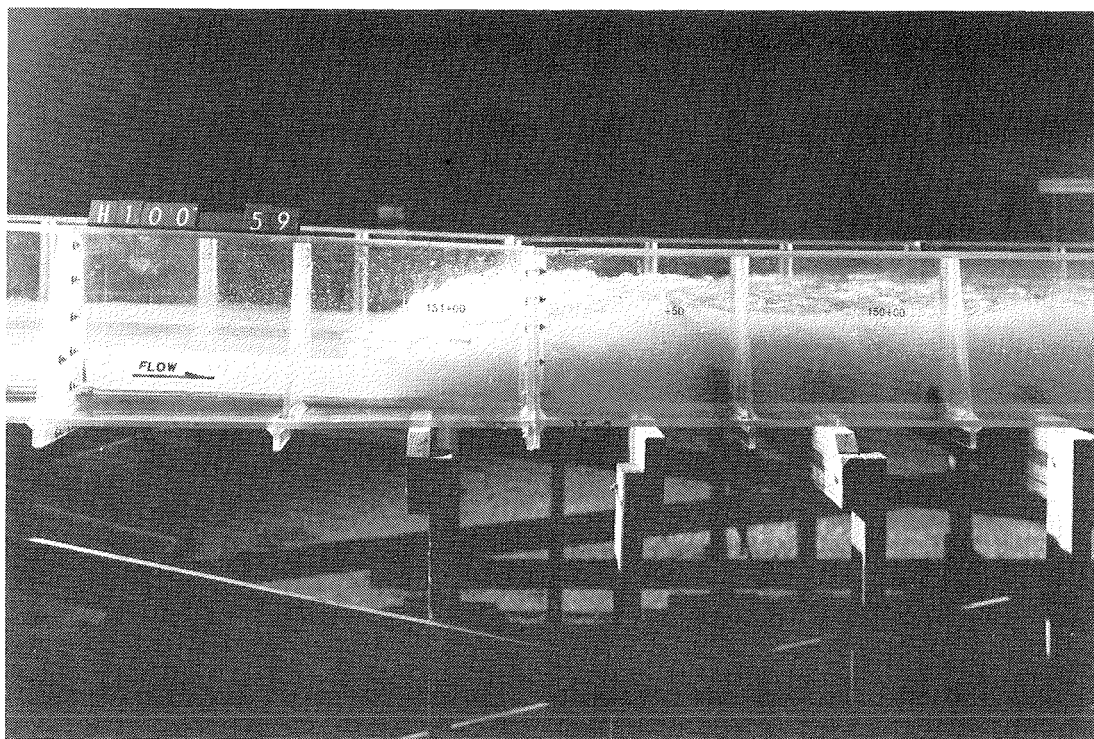
a. Looking downstream

b. Elevation view

Photo 14. Flow conditions with the type 4 design baffle blocks,
discharge 44,900 cfs, $n = 0.015$

19. Various sizes and arrangements of blocks were tested in an effort to determine the optimum size, number, and location of baffle blocks required for good energy dissipation (Plate 27). The type 4 design baffle blocks consisted of two rows of 8-ft-high by 8-ft-wide blocks followed by six rows of 4-ft-high by 4-ft-wide blocks between sta 150+40 and 148+59. The type 4 design baffle blocks fixed the location of the jump and adequately dissipated the flow energy, resulting in acceptable flow conditions downstream of the jump (Photo 14).

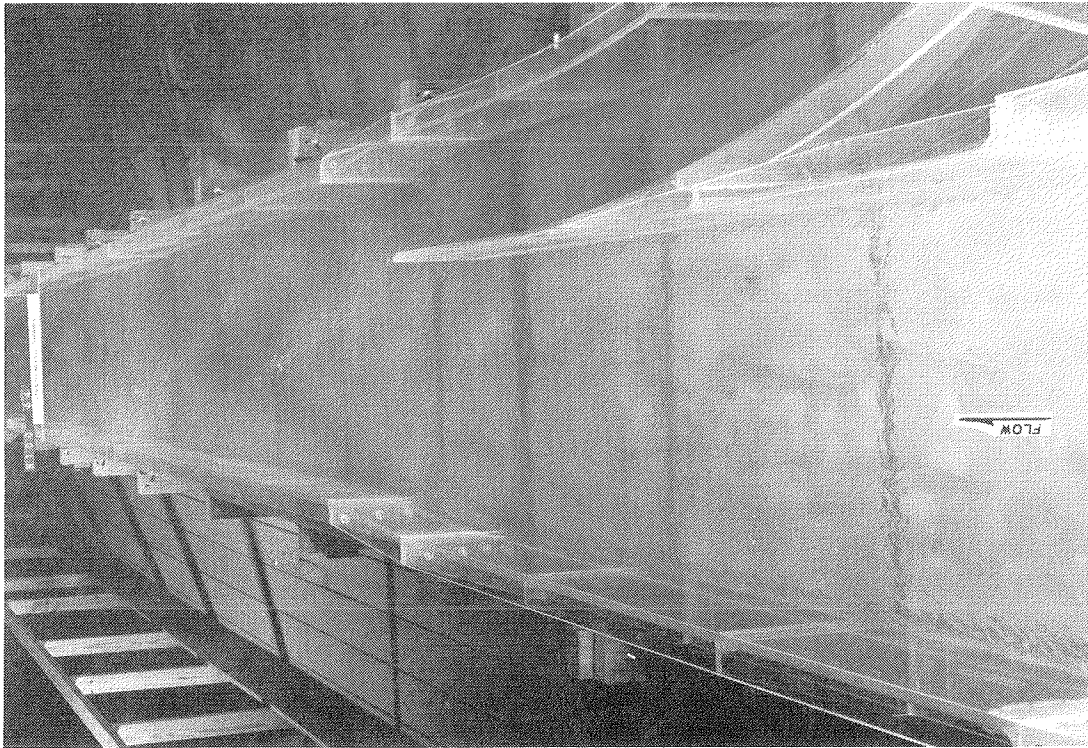
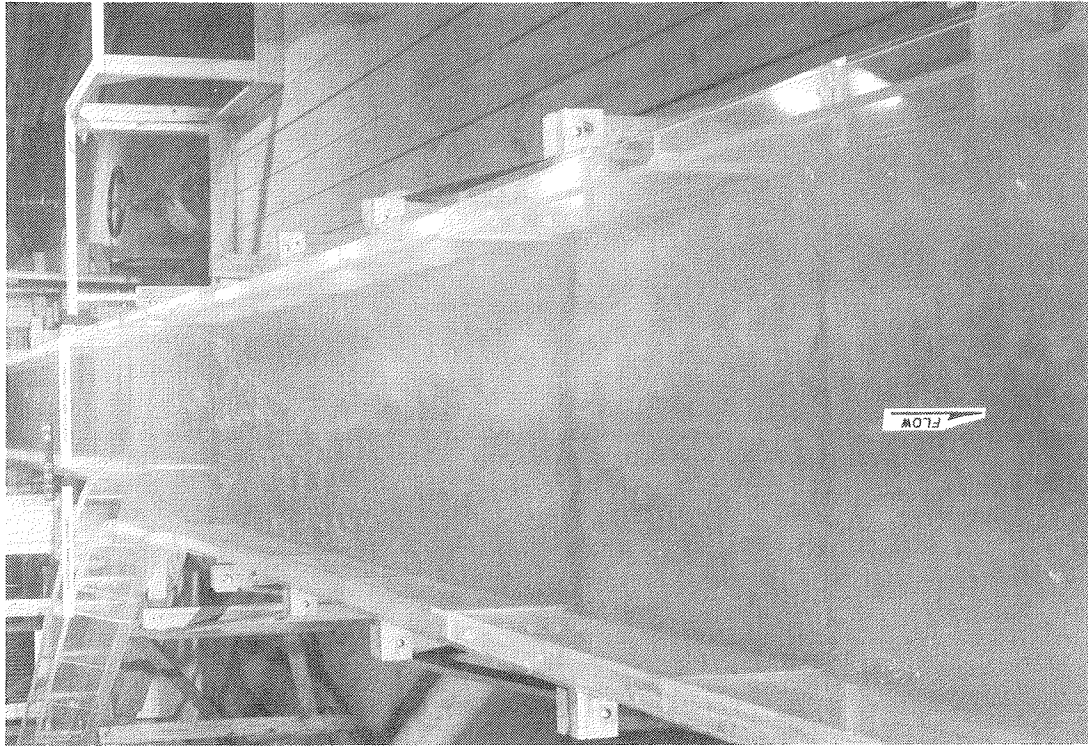
Photo 15. Flow conditions, type 1 (original) design Puerto Nuevo/Guaracanal confluence, discharge 26,100 cfs in Puerto Nuevo, discharge 8,000 cfs in Guaracanal, $n = 0.012$

21. Water-surface elevations and profiles for the entire reach of channel reproduced are shown in Tables 8-10 and Plates 28-35. Flow conditions in several reaches are shown in Photos 15-17. Flow conditions in the vicinity of the Puerto Nuevo/Guaracanal Channel confluence were deemed acceptable. However, adverse flow conditions were present at the Puerto Nuevo/Buena Vista Diversion Channel confluence with a discharge of 37,900 cfs and 4,200 cfs in the Puerto Nuevo and Buena Vista Diversion Channels, respectively. Standing waves, which initiated in curves 12 and 13 (first two curves upstream of the confluence) and at the 1-ft wall offset at sta 207+00, reverberated off the channel walls downstream of the area where the flows of the two channels merge (Photo 16). This resulted in large standing waves downstream of the confluence (within curve 11, Plate 30). Modifications of the confluence wall would not improve flow conditions downstream of the confluence because flow disturbances were initiated upstream of the confluence. Major geometrical changes, such as increasing the radius of curvature and/or incorporating spirals in curves 11, 12, and 13, would be required to improve flow conditions in the confluence vicinity.

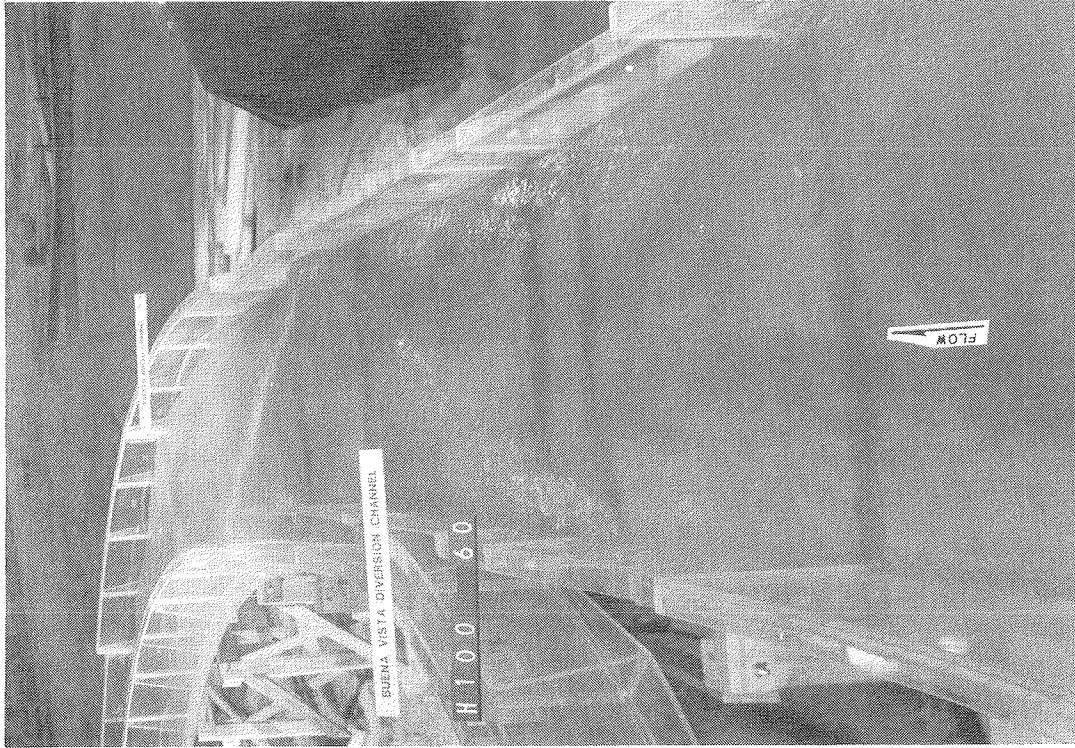
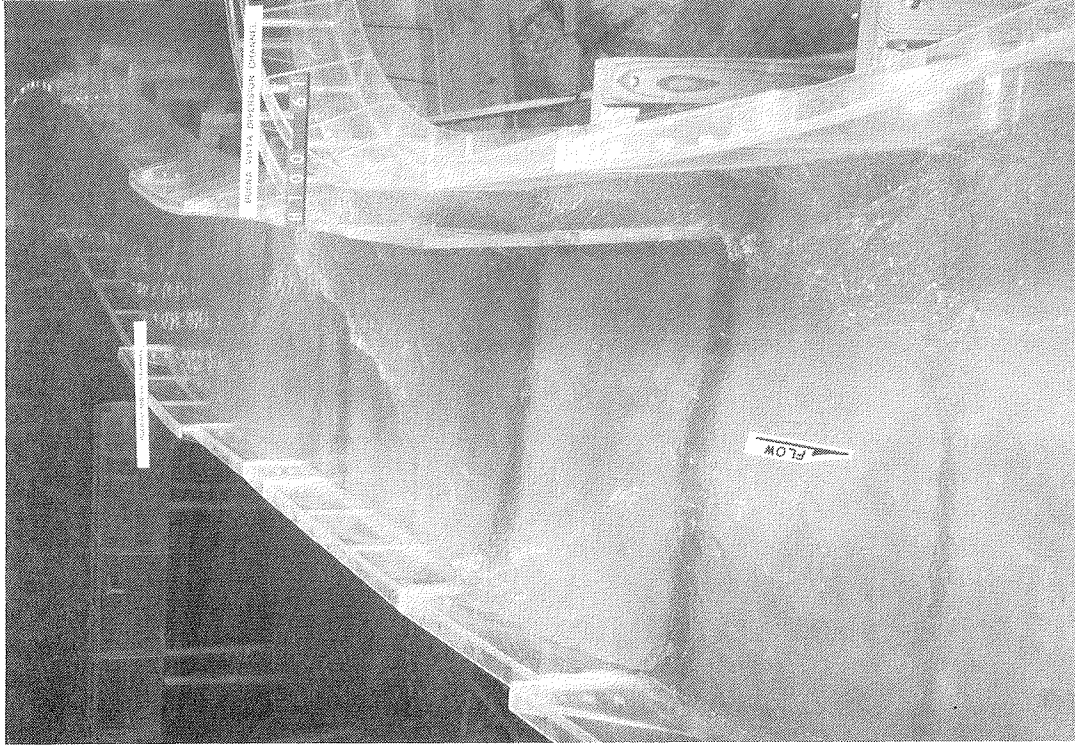
Photo 16. Flow conditions, type 2 design channel with type 4 design Puerto Nuevo/Buena Vista Diversion Channel confluence wall, discharge 37,900 cfs in Puerto Nuevo, discharge 4,200 cfs in Buena Vista Diversion Channel, $n = 0.012$

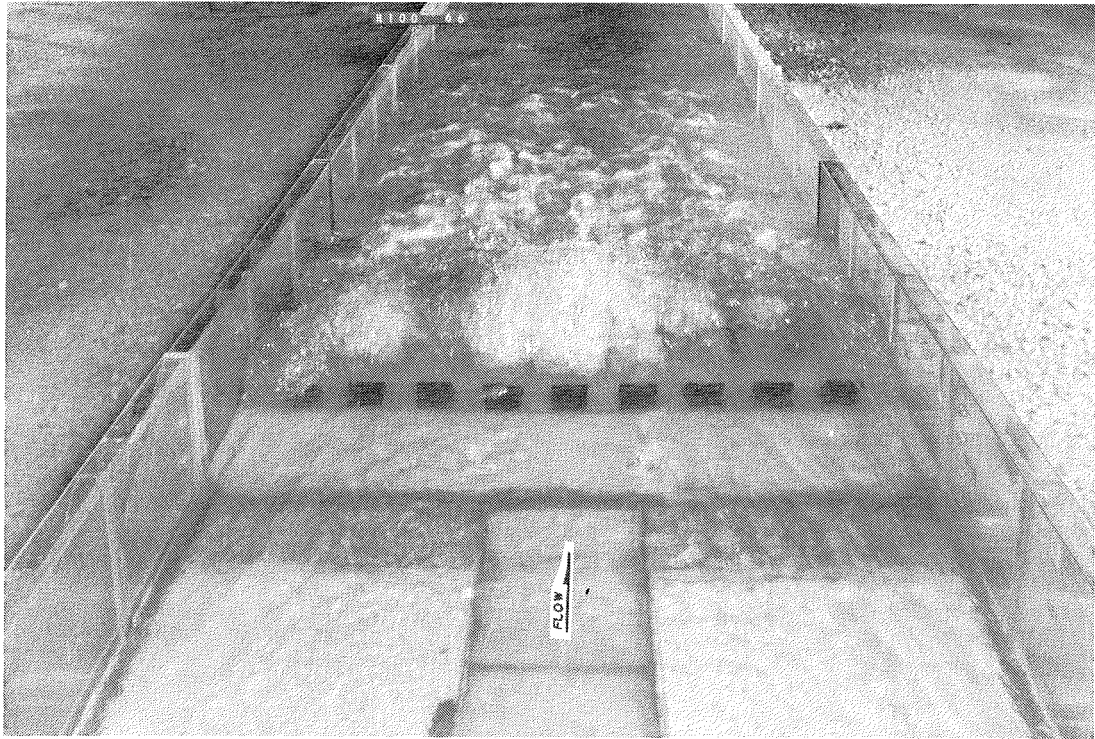
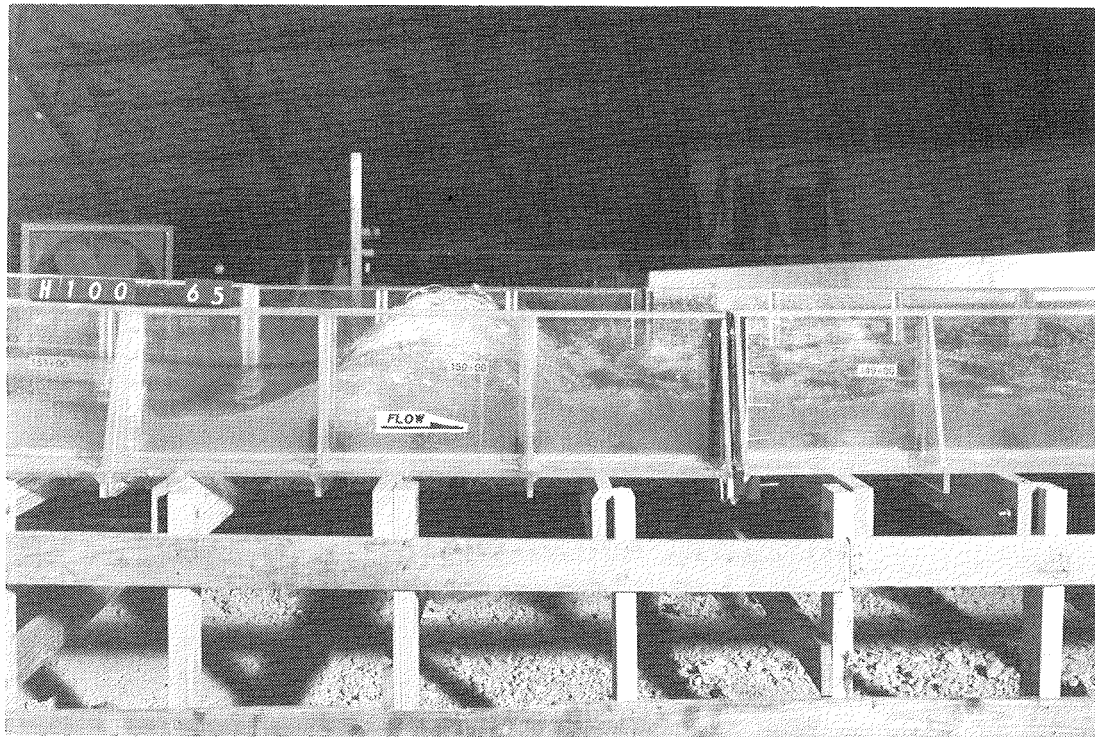
Photo 17. Flow conditions with the type 4 design baffle blocks,
discharge 44,900 cfs, $n = 0.012$

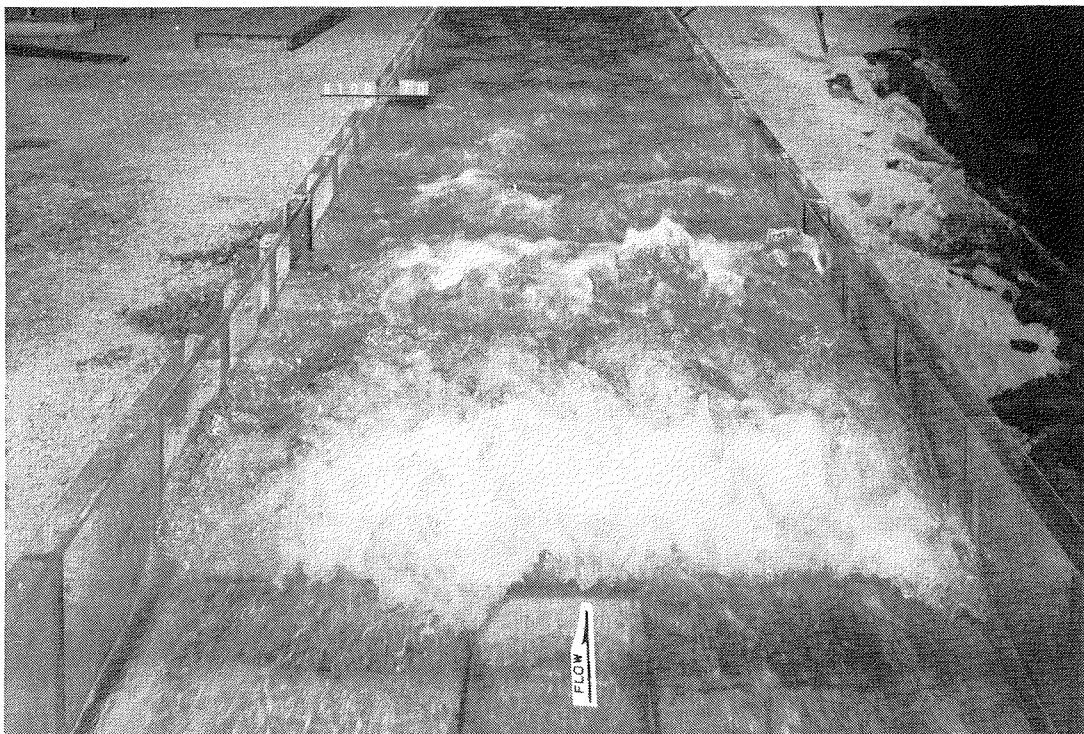
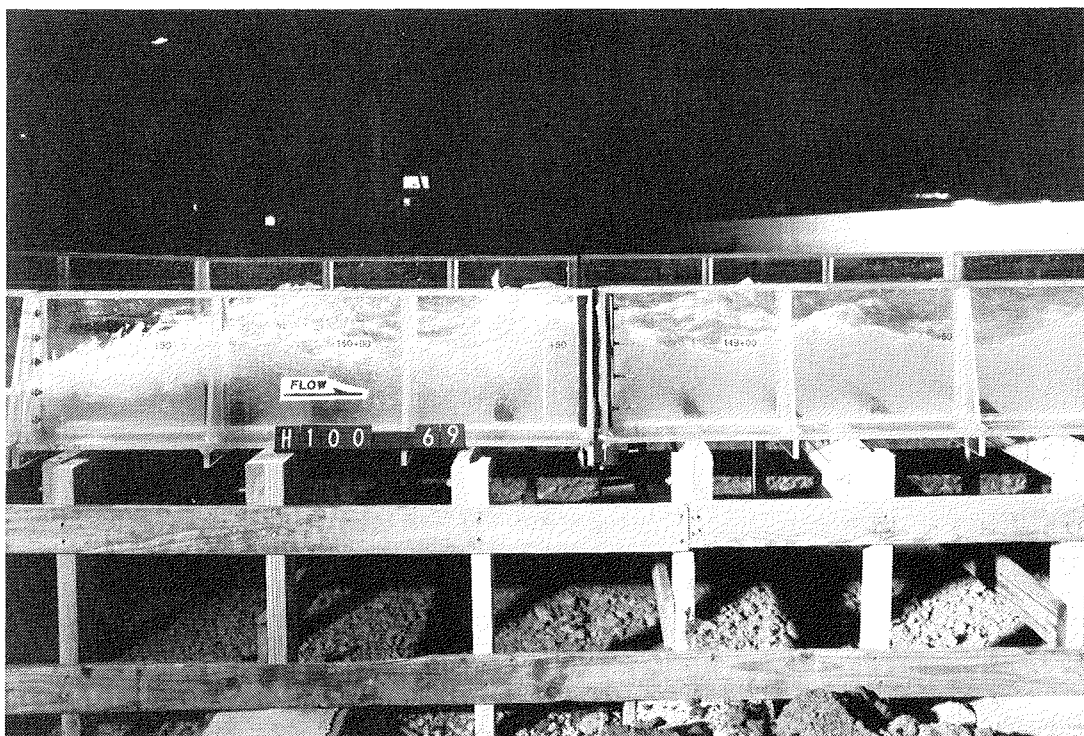
Photo 18. Flow conditions with the type 6 design baffle blocks,
discharge 44,900 cfs, $n = 0.012$

24. Tests involving baffle block modifications were conducted in an attempt to fix and stabilize the hydraulic jump. Two additional baffle block designs were tested (types 5 and 6, Plate 38). The type 6 design baffle blocks fixed the location of the jump and adequately dissipated the flow energy, resulting in acceptable flow conditions downstream of the jump. Test results with the type 6 design baffle blocks are shown in Table 13, Photo 18, and Plate 39.
